CERTIFICATE OF SURVEY

Norman C. Caldwell  
Registered Land Surveyor  
Sheet #1 of 2

Description: Lot # 42 of plat of AuSable Banks, a subdivision in Sections 11 & 12, T 26 N, R 3 E, Mentor Township, Oscoda County, Michigan.

Survey made for Russell Leckner

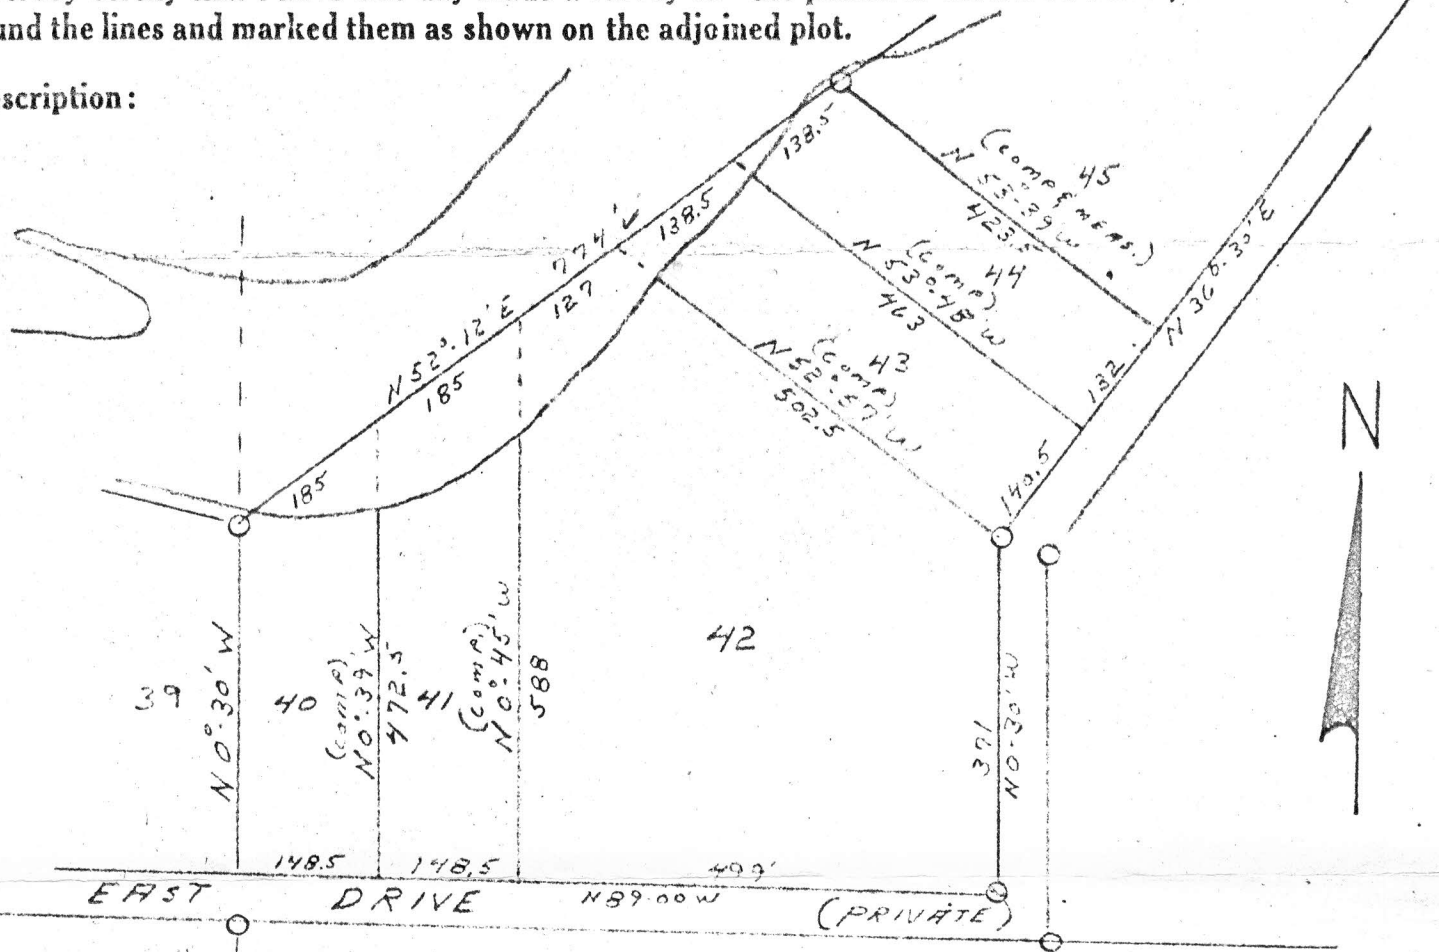
DIAGRAM # 1

In the process of surveying Lot #42 it was found that there is a shortage in the Plat distance along the South boundary of Lot # 42. The Plat shows 499 feet, and we have measured 474.3 feet. (Between authentic, original monumentation)

With the use of rectangular co-ordinates I have determined that this erroneous distance was used to compute the bearing and distance of the river course along Lots #40, 41, 42, 43, & 44, which in turn makes this dimension erroneous.

From an examination of the recorded plat I found that the direction of the side lines of the various lots in this area had been determined as follows, based on dimensions along the river traverse line: Lots #40 & 41 received 185' each, Lot #42, 127', and Lots #43 & 44 138.5' each, with a total distance of 774', which is erroneous as explained above.

Diagram #1 on Sheet #2 shows the dimensions as reported on the recorded plat.

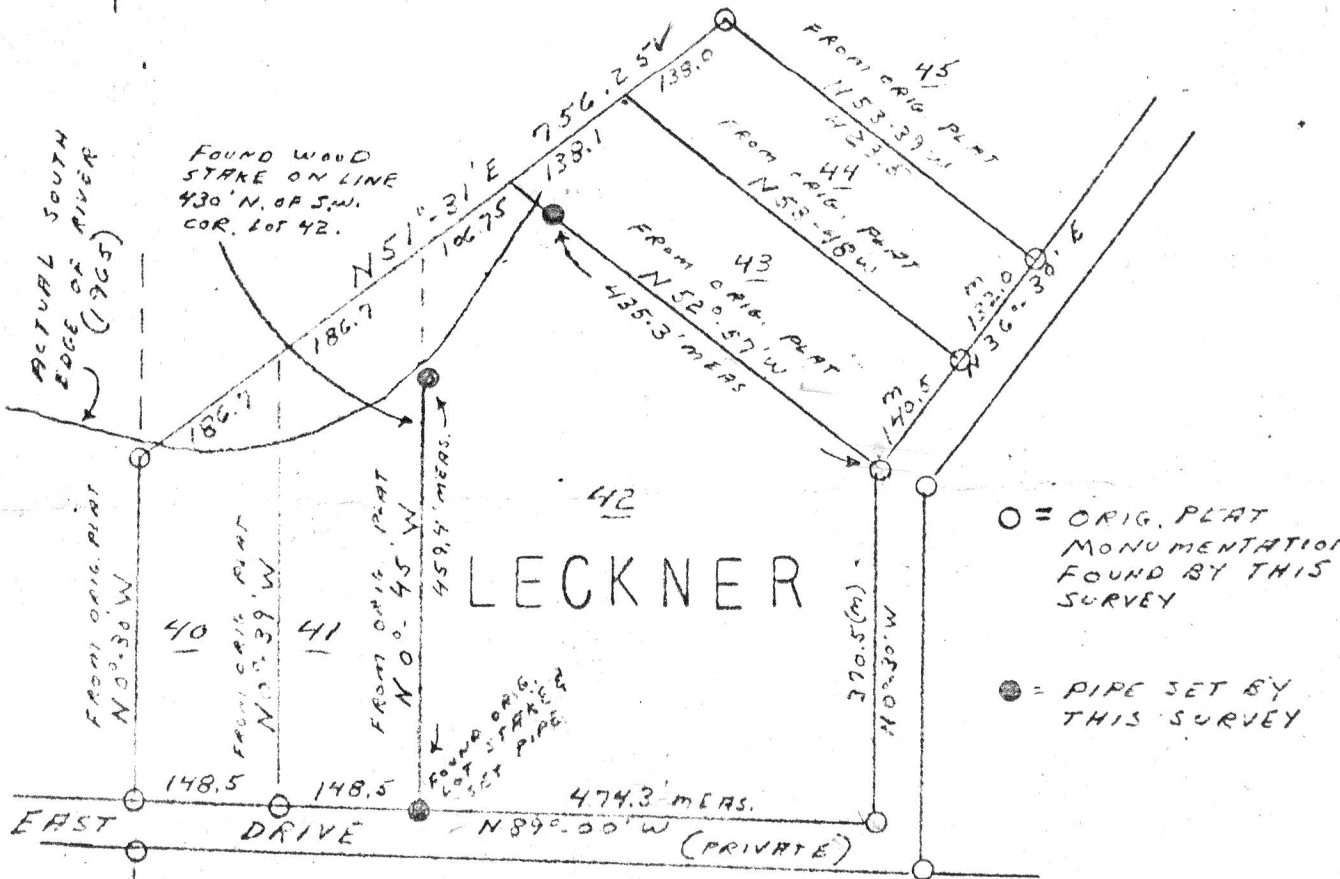
DIAGRAM # 2

By a very careful search I have found the original lot corner at the Southwest corner of Lot #42. I found a 2"X 2" hub, broken off at the ground surface, but still in good condition below the surface.

Using these rectangular co-ordinates, based on the erroneous dimensions, I have computed the direction of each side lot line, as intended on the original plat, and staked them in the field as such. As verification of this method, we found an old stake on the West line of Lot #42 on our line as explained above.

By using these bearings on the side lot lines it becomes necessary to adjust the intersection dimensions of said lot lines and the TRUE RIVER TRAVERSE LINE. These dimensions are shown on the sketch at the bottom of page #2 of this report.

✓ The Concrete plat monument at the North corner of Lot #44 has been disturbed.

✓ Due to the gross errors in the original plat, this survey may be subject to review and some slight adjustments.

Diagram #2 on Sheet #2 shows the dimensions as found in this survey.
